Residential Foundation Repair

Childress Residence: Sylacuga, AL

Footing Foundation Repair Due to Sinkhole

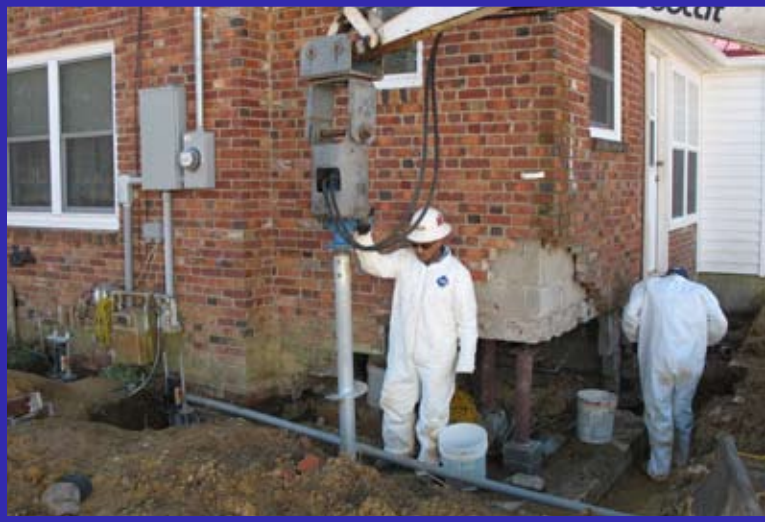
Helical Piles Driven and Terminated at 5,500 ft/lbs. of Torque

Based on the geotechnical report and construction conditions of residence, the recommendation was to install a combination of 3 1/2" 36000 series pipe helical piles with an 8" and 10" helical configuration, installed to 5,500 foot-pounds of torque in conjunction with grout and pipe injection to stabilize the sinkhole area of the house at its rear corner.

AFSB installed seven Drive Rite Piering System™ 36000 series 3 1/2" helical piles with footing brackets (#98010G) and three 3 1/2" helical piles with new construction pile caps as recommended by engineering report to repair and replace the damaged foot-

ing, block foundation wall, and brick veneer. Installation of helical piles ranged from 11 to 40 ft. of depth.

Recommended torque was achieved and adequate pressure was applied to the lifting brackets to stabilize the footing and to reconstruct the failed footing area for reinstallation of foundation block and brick veneer.

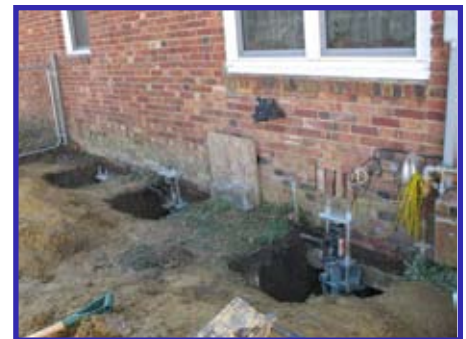
Drive Rite 98010G Footing Brackets
