# State Park Retaining Wall Repair

Lake Greenwood State Park: Ninety Six, SC

*Historic Retaining Wall Repair*

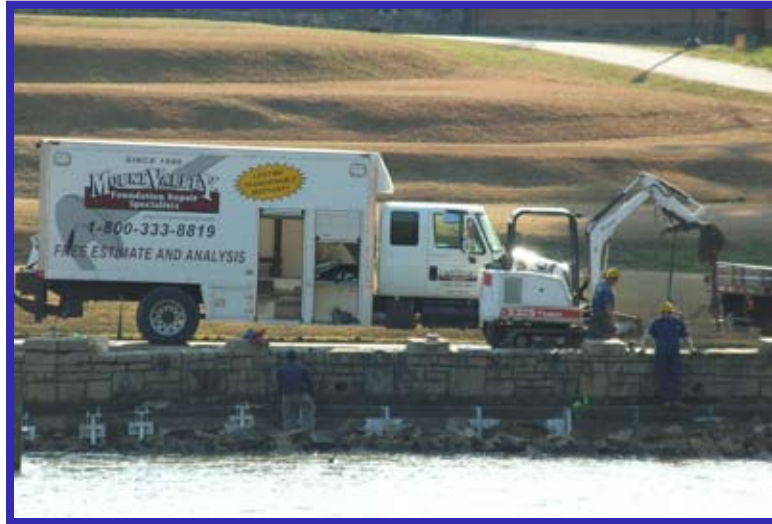
*Helical Piles with Lifting Brackets along Retaining Wall*

The wall consisted of rectangular shaped granite stones laid in a running bond resting on an original un-reinforced concrete footing. The wall was suffering from years of undermining by lake currents and wave erosion. A twenty year old concrete under-pour that projected

off the original stone face by as much as twelve inches represented an earlier attempt at repair and further complicated problems by accelerating the rotation of the dropping wall.

After consideration of many different options, the State Parks Service chose Mount Valley Foundation Repair Specialists to install Drive Rite™ 25000 series helical piles along with custom fabricated lifting brackets to stabilize approximately 350' of this 800' wall.

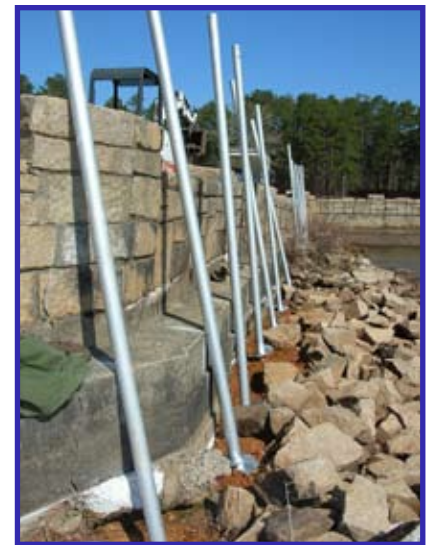
*Helical Piles Positioned along Wall*

The single 10" diameter helical piles were driven to weathered rock at approximately 20' and 4,000 foot-pounds of torque. The lifting brackets were installed and adequate pressure was applied to stabilize the retaining wall.
